November 2017 - Alcatraz Cellhouse Repairs Completed Ahead of Schedule

Perini completed its contract to stabilize and repair the walls of the historic cellhouse on Alcatraz Island ahead of the contractual completion date of December 10, 2017. After achieving substantial completion of Phase II on October 26th, we completed the last remaining item of installing the new recreation yard door on November 15th and left the island for the final time. This project for the National Park Service was performed in two main phases and consisted of removal and replacement of deteriorated concrete at both exterior and interior walls, installing cathodic protection systems, and painting the walls with an elastomeric coating to prevent future deterioration from the harsh wind, rain and salt air. The popular tourist destination remained open to the public throughout the project performance.

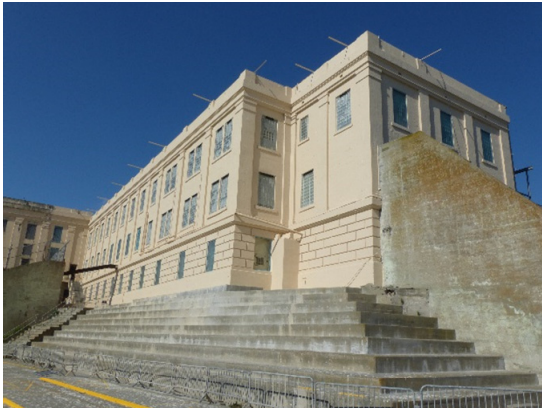
Historic cellhouse repairs completed

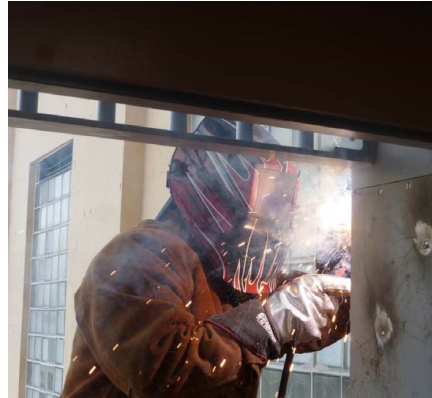
Recreational yard door installation

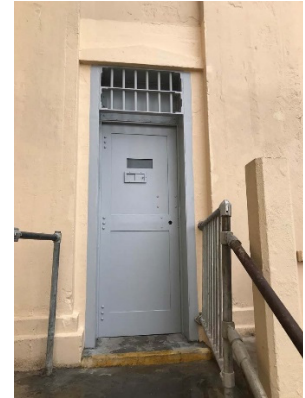
Recreational yard door completed

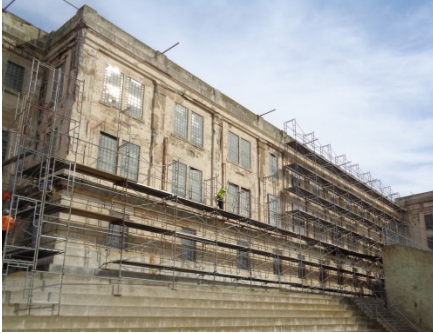
Cellhouse exterior being readied for repair.

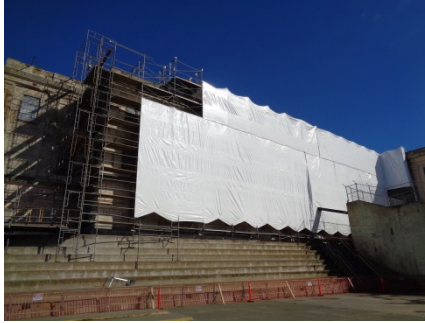
Shrink wrapping provides a visual barrier so that work does not disturb the island's birds.

Scaffolding was erected in January and then shrink-wrapped in February to provide a visual barrier to birds. In addition to being a major tourist attraction, the island is also a bird sanctuary, and our team has to take precautions against disturbing them. All workers had to attend mandatory bird awareness training provided by the NPS, and work activities have to be conducted with minimal noise and disruption to their habitat. The shrink wrap has the added benefit of providing weather protection for the work and also creates negative air pressure for the lead abatement activities that were the focus in

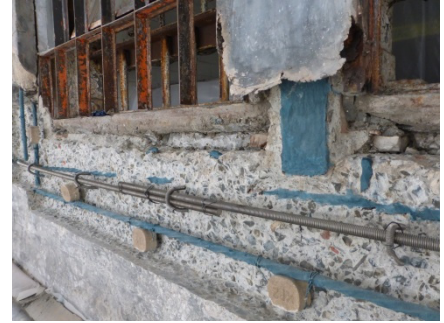
Window-sill mock-up showing corrosion inhibitor and cathodic protection.

March. Currently, mock-ups of the different types of repairs are being prepared for approval by NPS and its designer, before full repair work can be begin.
